**BLIND PASS INLET MANAGEMENT STUDY
2018 UPDATE**

Board of County Commissioners of Lee County

Aptim Environmental & Infrastructure, Inc.

August 2018

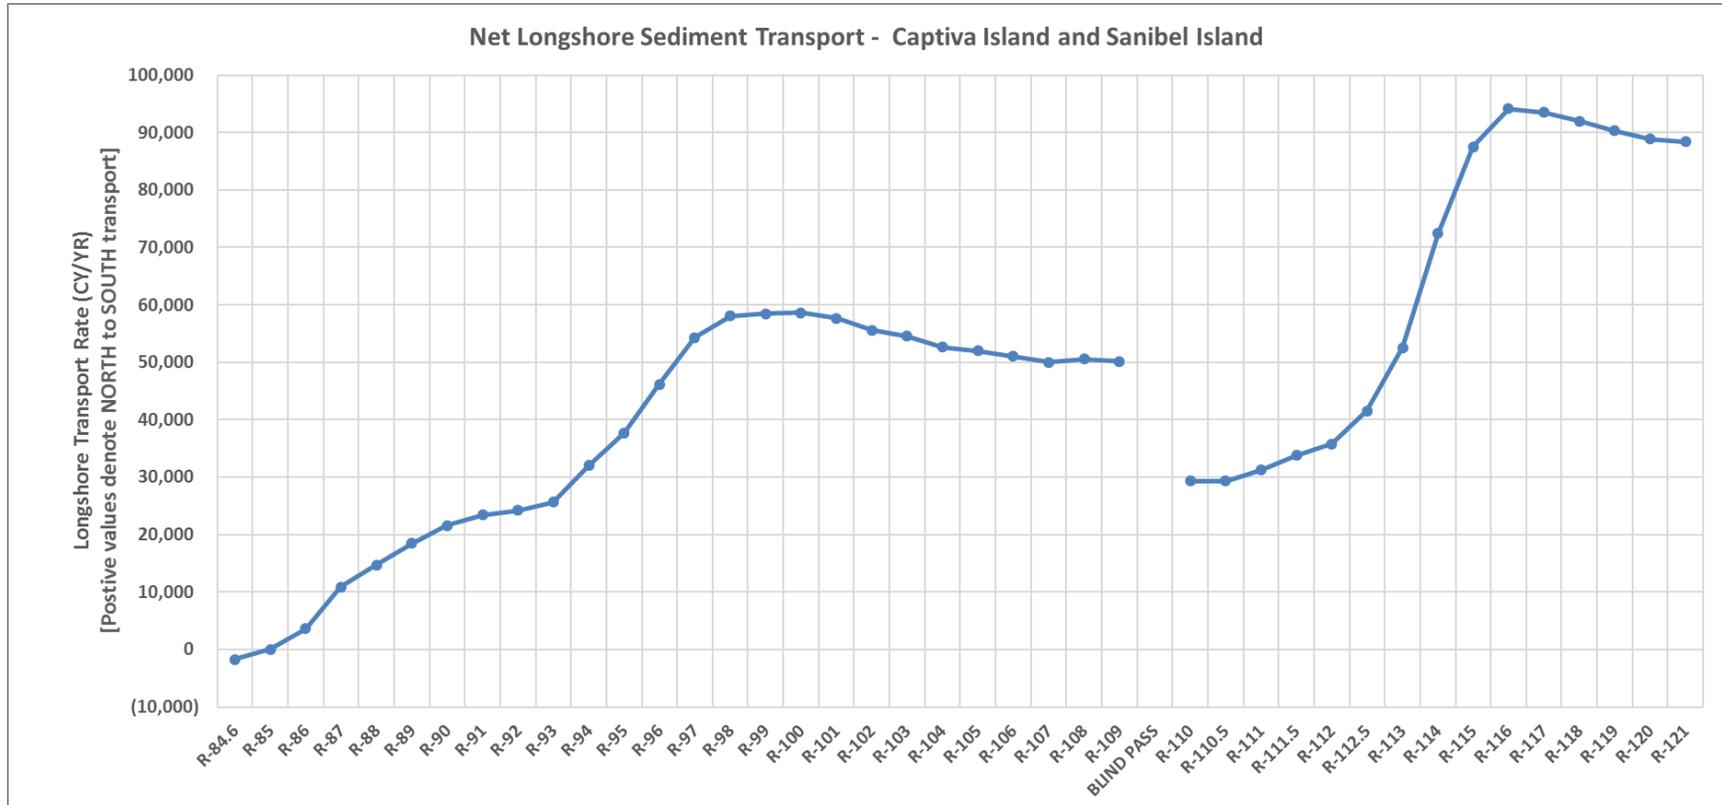
Figure 2-14: Net Longshore Transport Rates along Captiva Island and Sanibel Island.

Longshore transport is defined as the movement of sand within the surf zone in a direction parallel to the beach, depending primarily on the incident wave height and wave angle. The longshore transport curve is used to illustrate the direction of transport, north or south, along the study area. The shape of the curve is most informative in identifying erosion trends. The net annual longshore transport for the 2009 - 2015 period is presented in Figure 2-14.

A negative slope on the longshore transport line indicates accretion, which removes sand from the longshore transport. Conversely, a positive slope indicates erosion, which adds sand to the longshore transport. Transport is to the north when the curve is below 0 cy/yr. Transport is to the south when the curve is above 0 cy/yr.

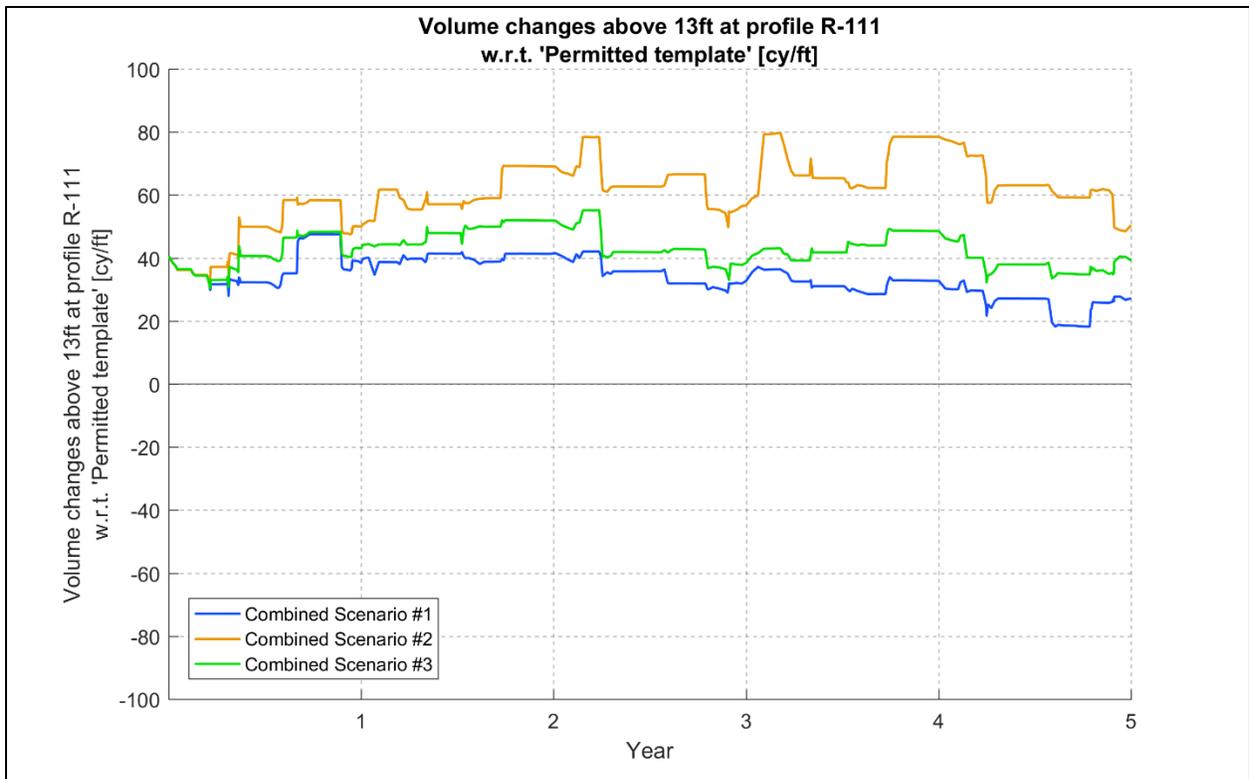
Figure 3-6. Net volume changes at R-111 relative to the permitted template (cy/ft).
